Manhole Inspection Summary

Manhole # S13AA1014MH

Insp Date: **1/26/09 10:28 AM**

Location Address: **3733 SPRINHILL AVE**

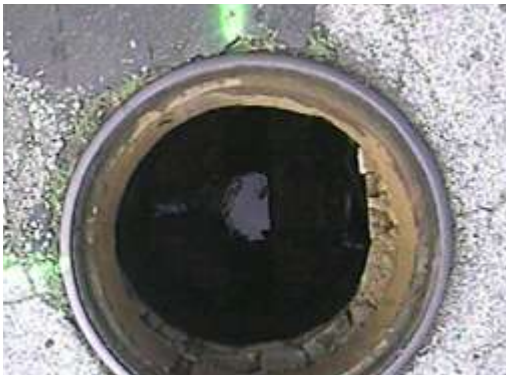
Top View

Offset: **3** (in.)

FRAME OFFSET

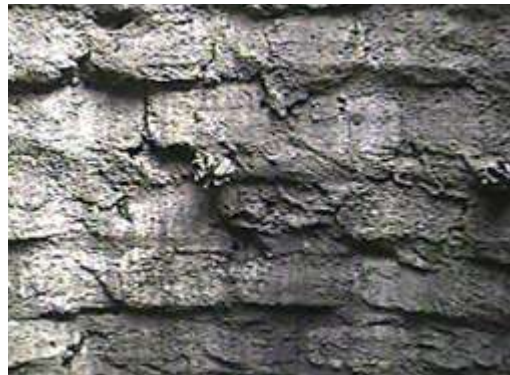
Defect 1

Count: **3** Missing: **1** ☒ **Corroded**

MISSING RUNG

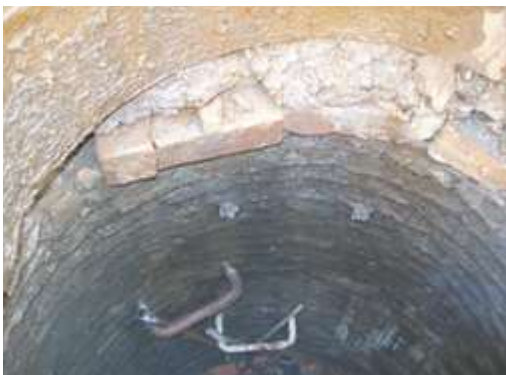
Defect 3

Condition: ☐ Sound ☐ Cracked ☐ Root Intrusion ☒ **Loose Brick** ☒ **Deteriorated**

CORBEL LOOSE BRICKS AND
DETERIORATION

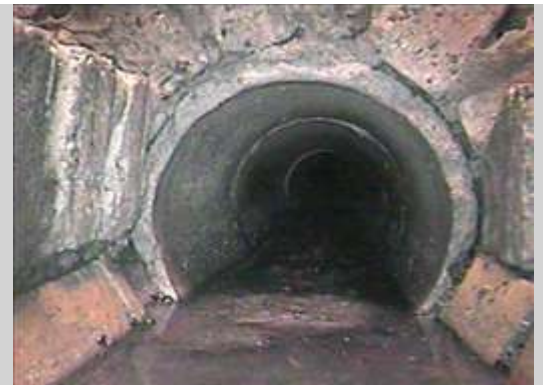
6 O'Clock Inflow

8 in. Circular Gravity Sewer
Pipe In @ 6 O'Clock

Pipe Height: (in.) Direct
Pipe Material: **Clay** ☐ Pipe Lined
Invert Depth: **7.30** (ft.) Flow Characteristics: **Slow**
Deposits: ☒ None ☐ Mud ☐ Sludge ☐ Debris ☐ Grease
Silt Depth: (in.) Deposits Extent:
Infiltration: **None** Pipe Seal Cond: **Cracked**

Connects To: **Stub connection / abandoned**

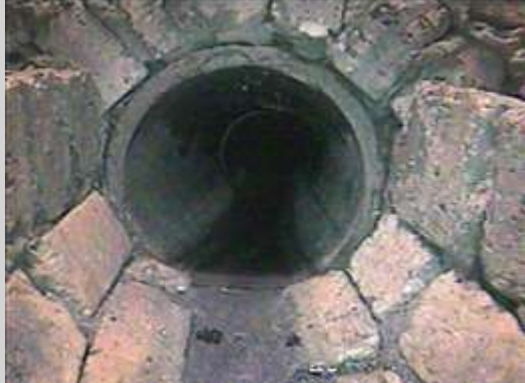
9 O'Clock Inflow

Infiltration: **None** Pipe Seal Cond: **Cracked**
